Report 1928

**EXPERIMENTAL MODEL,
MARGINAL-TERRAIN ASSAULT BRIDGE AND ARMORED
PERSONNEL CARRIER TRANSPORTER AND LAUNCHER**

**U. S. ARMY MOBILITY EQUIPMENT RESEARCH AND DEVELOPMENT CENTER
FORT BELVOIR, VIRGINIA**

This report presents information on an experimental model of a lightweight, short-span, marginal-terrain assault bridge and transporting launcher. The model tested is a 33-foot bridge span transported and launched by an M-113 Armored Personnel Carrier.

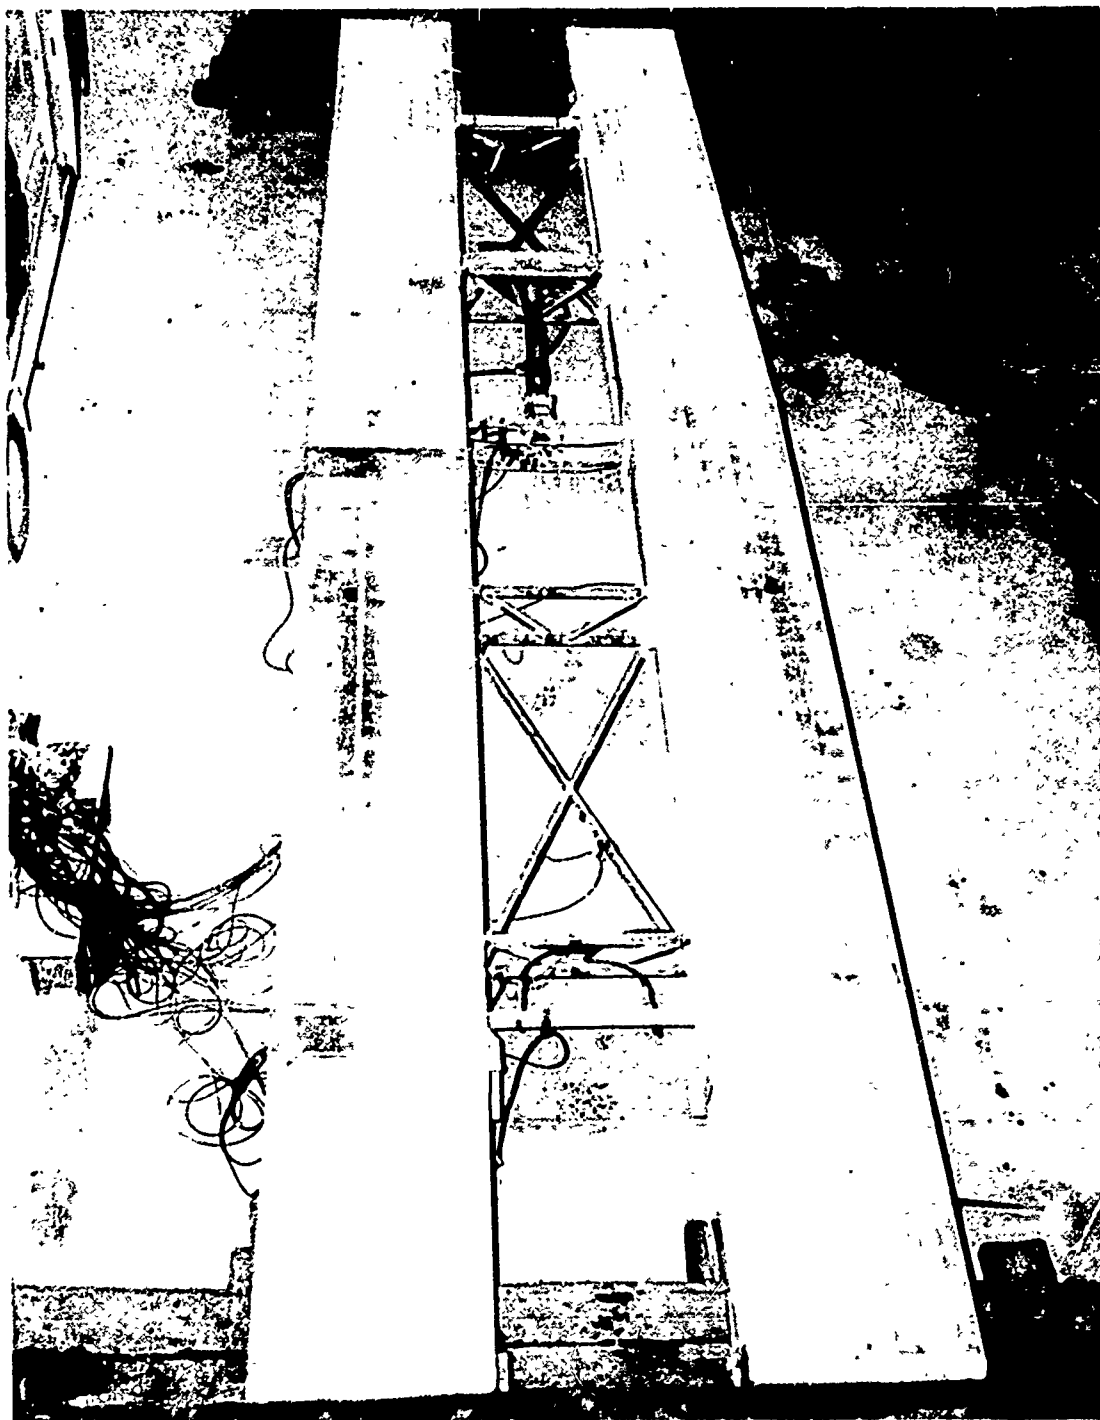
N8903

Fig. 1. Overall view of bridge set up for dynamic traffic test.

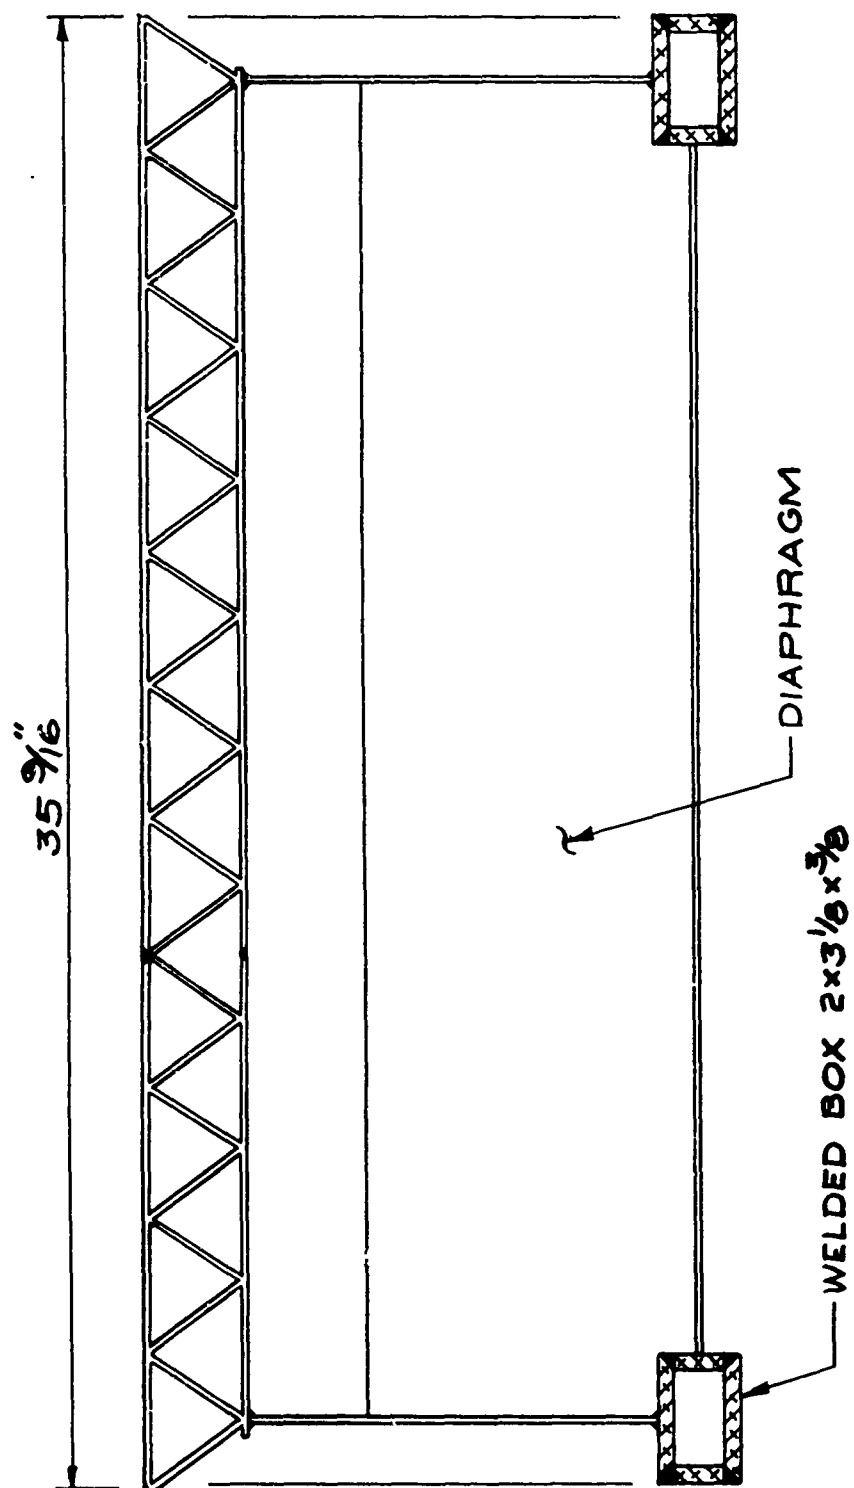
Fig. 2. Typical tread cross-section.

Each tread is constructed of two welded-box tension chords of 7039-T61 aluminum, flat-sheet webs of 7039-T61 aluminum, and an extruded deck panel of 6061-T6 aluminum, all connected by welding (Fig. 2). The deck panel extrusion has a cross section in the shape of a Warren truss. Two such sections were welded together and cut to size to form the decking of each tread. This configuration has stiffness in two directions.

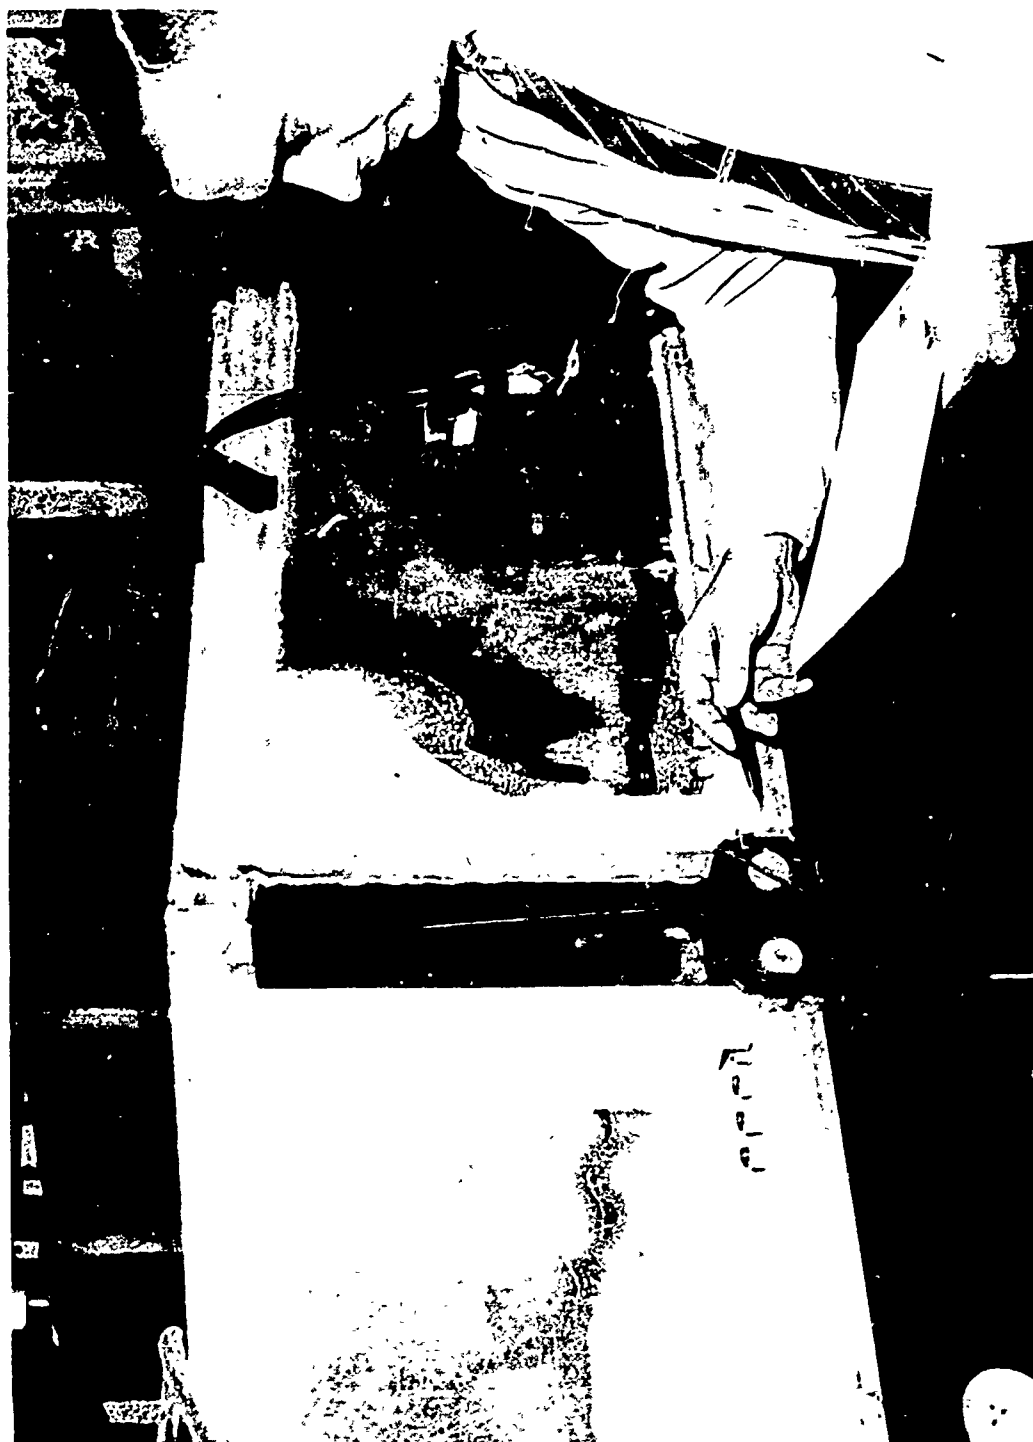
N8581

Fig. 3. Two-centered, noneccentric hinge.

The heat-treated 4340 steel hinge is a double-centered, noneccentric unit which provides 180 degrees of rotation, 90 degrees about each pin (Fig. 3). The pins are also heat-treated 4340 steel and are self-lubricated by a polytetrafluoroethylene coating (Teflon)*.

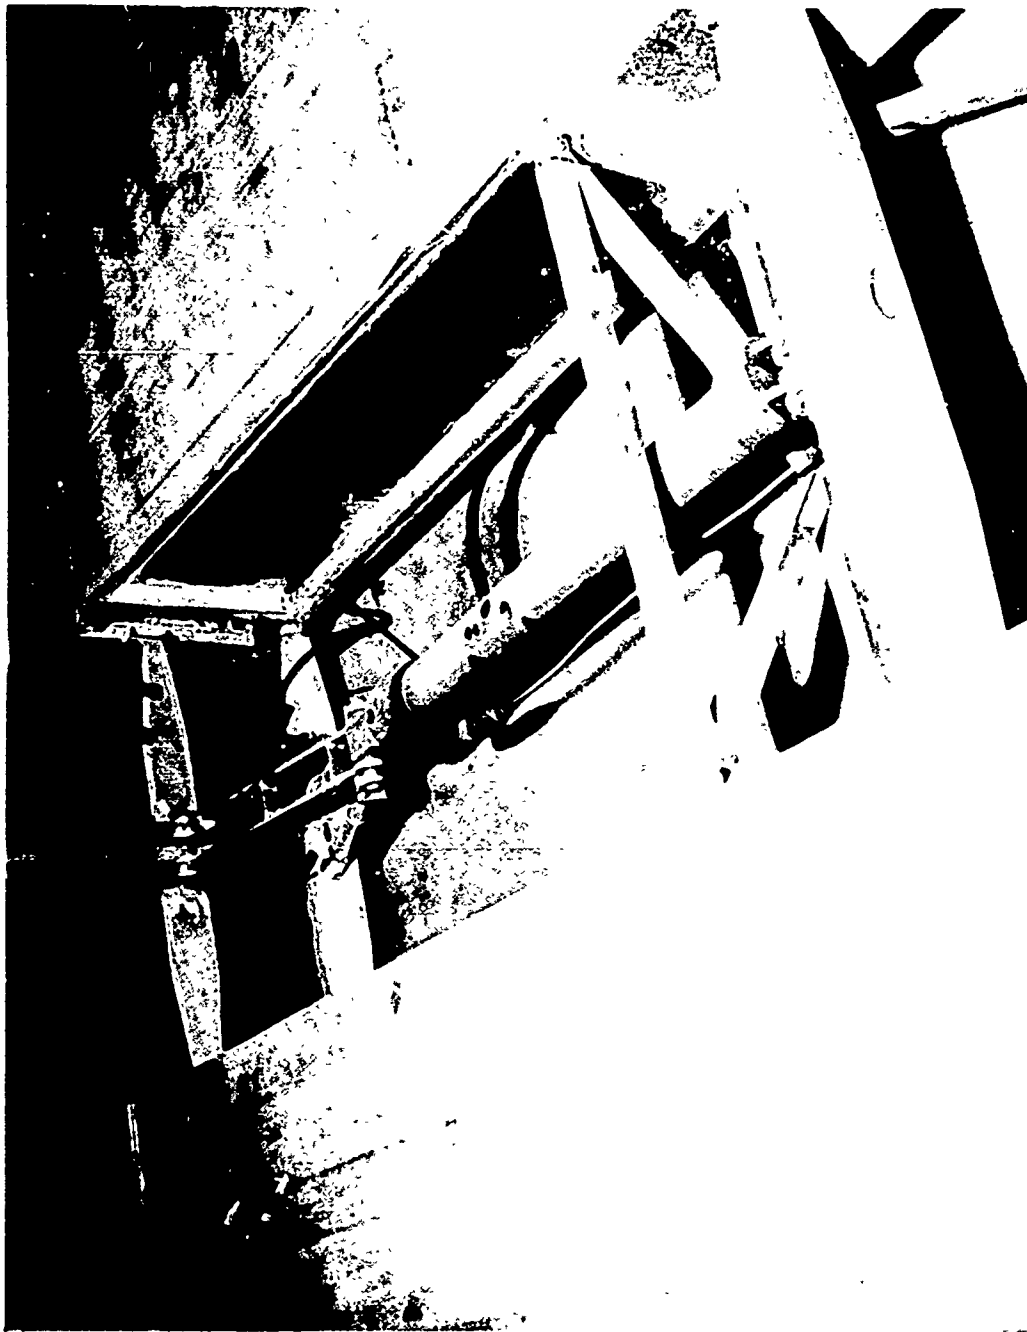
N8898
Fig. 4. Folding mechanism (note the hydraulic cylinder and the three-link arrangement).

The folding mechanism is a three-link arrangement actuated by a 3-1/2-inch bore, 36-inch stroke hydraulic cylinder (Fig. 4). The compression link provides the proper mechanism configuration during actuation and expands through part of the cycle.

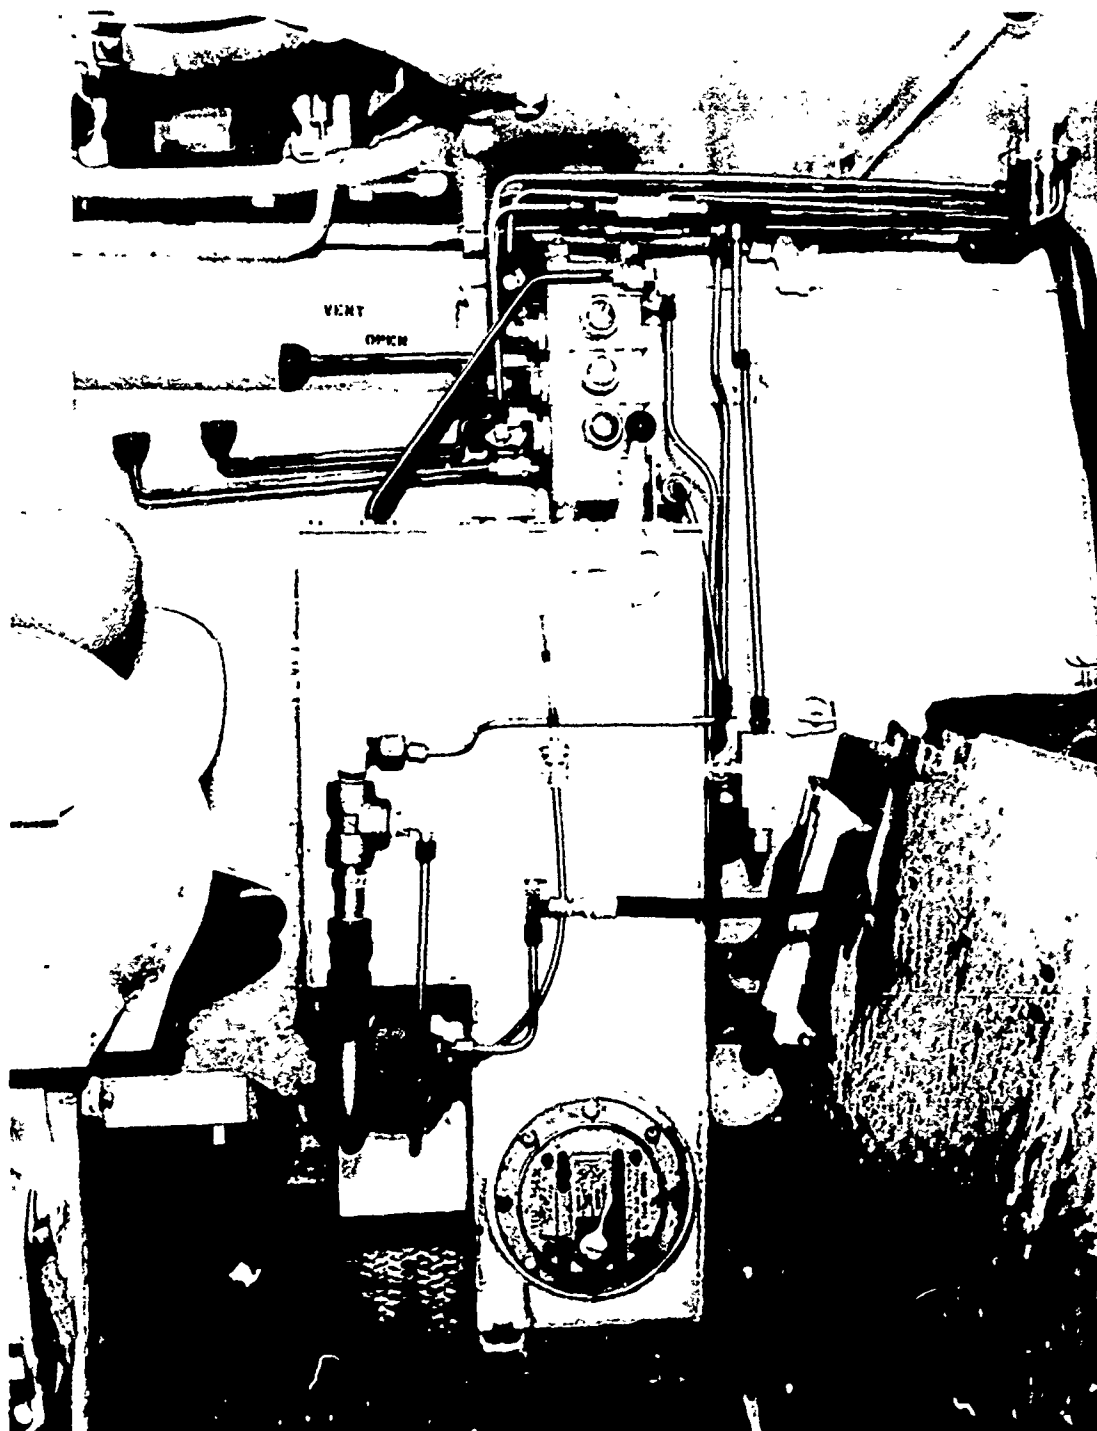
P7707

Fig. 6. Hydraulic power unit installation and controls.

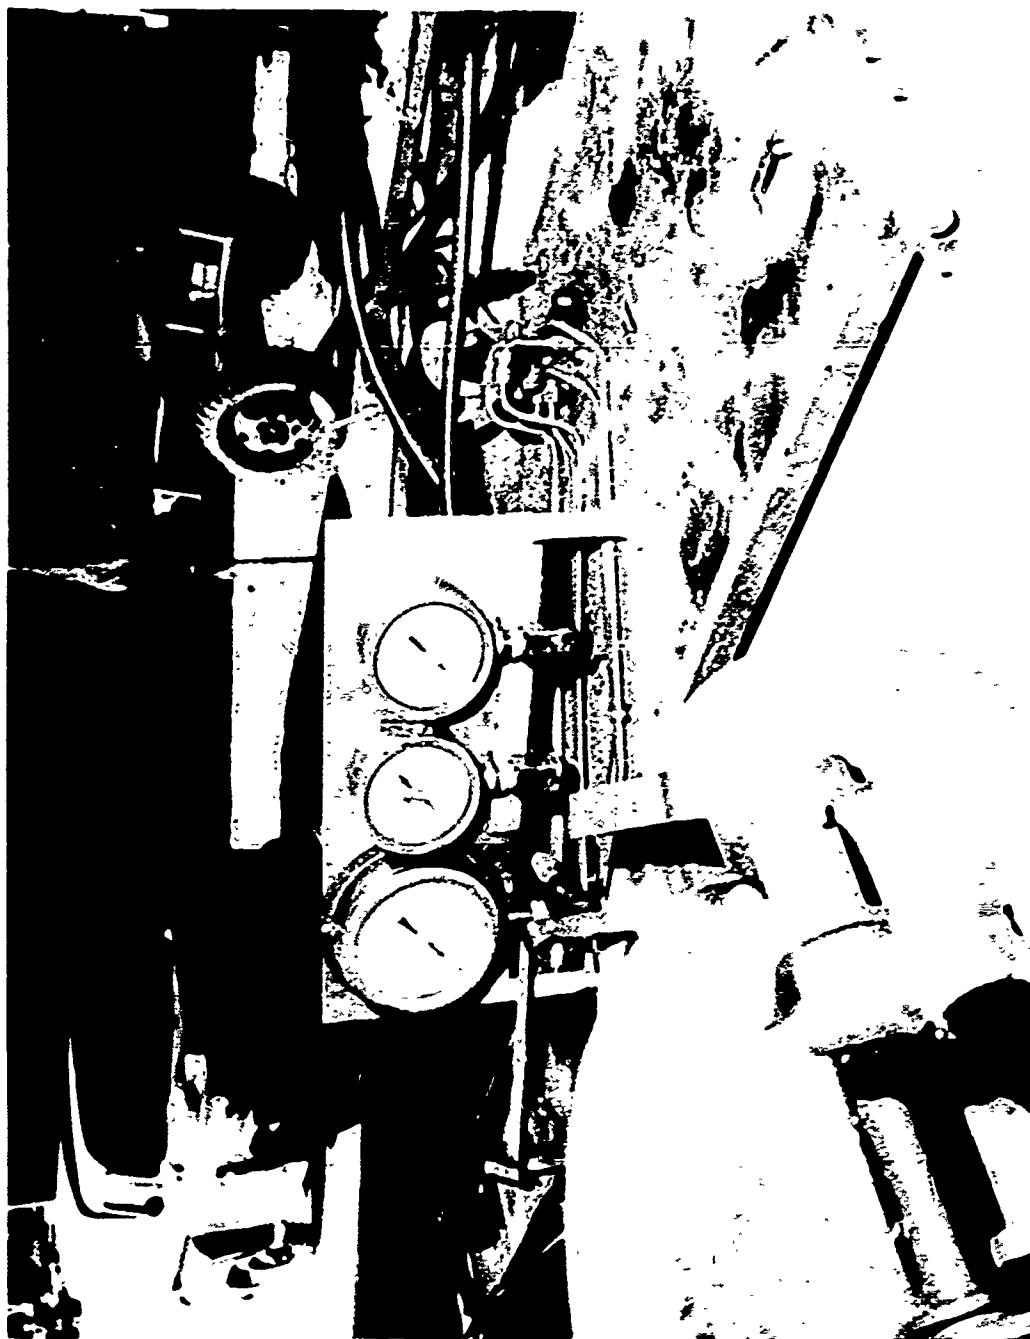
P1776

Fig. 7. External piping and hydraulic test gages.

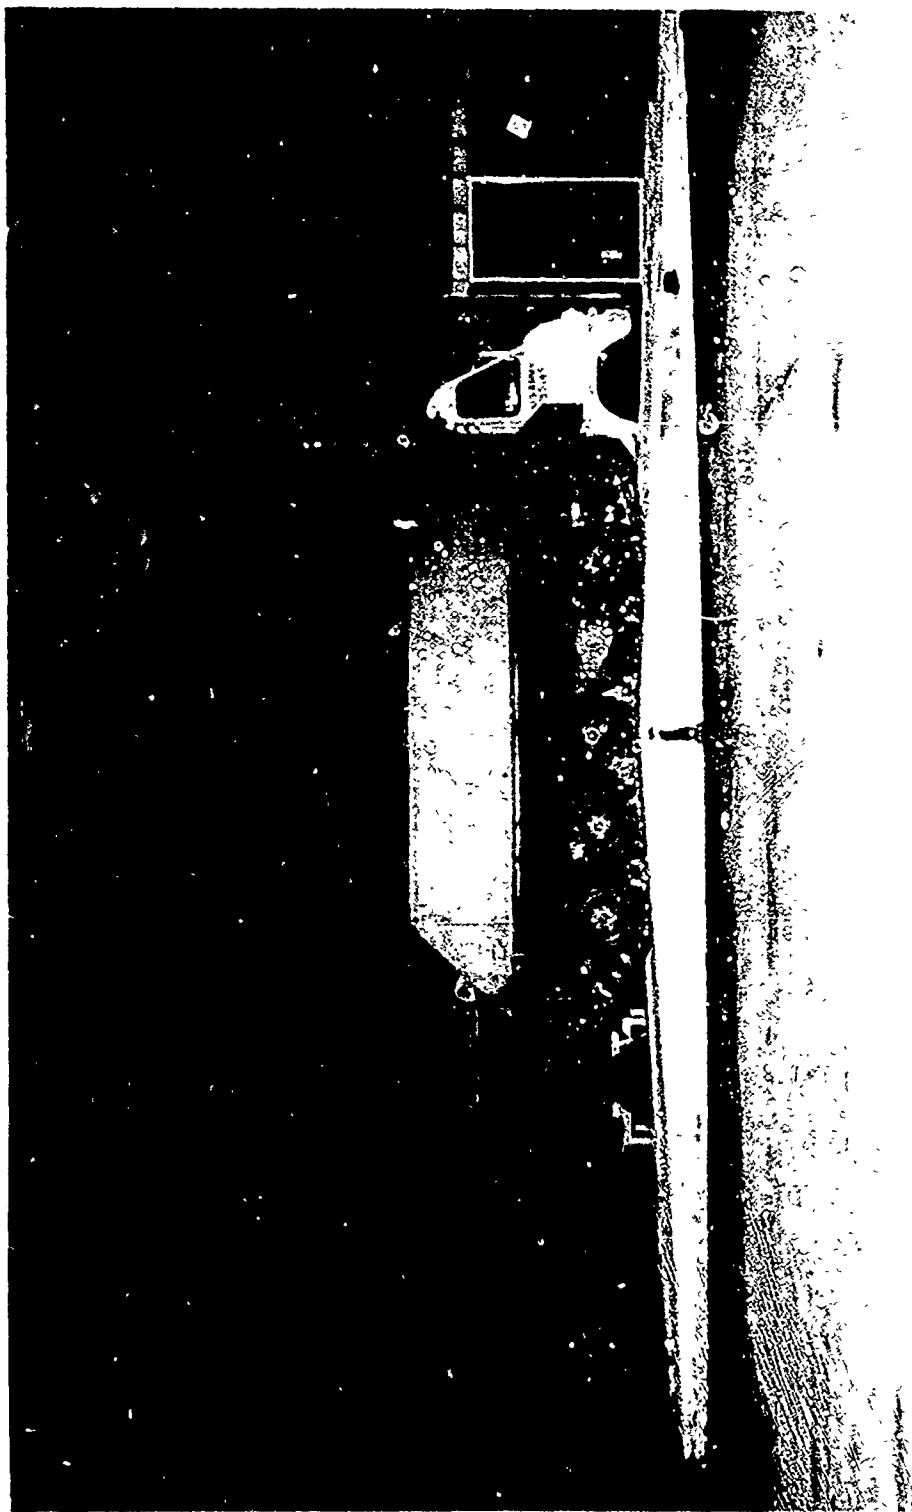
N8911

Fig. 9. Bridge under dynamic loading.

Traffic tests were conducted with an APC having a gross weight of 24,300 pounds. Five hundred crossings were made, half from each direction. The speed range for these crossings was approximately 20 to 25 miles per hour. These speeds are well above the speeds that would be expected in the field, but crossing tests were purposely conducted at these speeds to create an extreme condition.

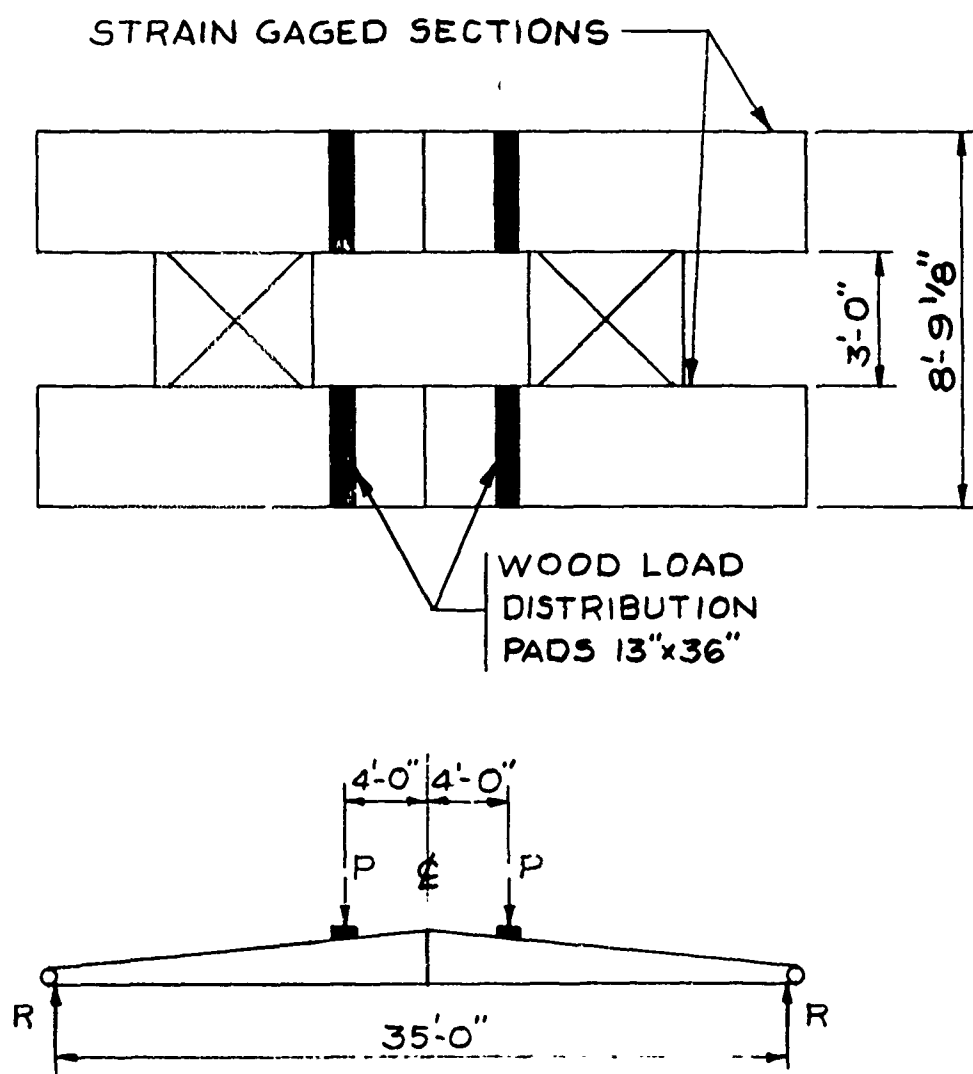
Fig. 10. Load Position 1.

Strain gage readings were taken for five different loading conditions. Figures 10 through 14 show the positions of the loads.

On the initial loading at load position 1 (Fig. 10), the transverse welds in the bottom chord of each tread section failed while the load was increased from P equals 22,000 pounds to P equals 24,500 pounds. The failure was through the weld metal which showed necking before failure. Examination of the fracture showed high porosity throughout the weld. It should be noted that these welds are not in the design but were an expedient so that the experimental model could be built with available plate material. These box sections on a production unit will be one-piece extrusions and, therefore, not subject to transverse welds (Fig. 2). It should also be noted that the 6061-T6 extruded aluminum deck was also an expedient: an available section which will be replaced in production by a 2-inch-thick extrusion of similar shape in 7005-T53 aluminum. This alloy change gives an increase in yield strength to a minimum of 44 ksi and a reduction in cross-sectional area of approximately 5 percent. It also lowers the neutral axis of the tread section, thus lowering the maximum achieved stress at a given load. The welded yield strength is approximately 100 percent higher than welded 6061-T6.

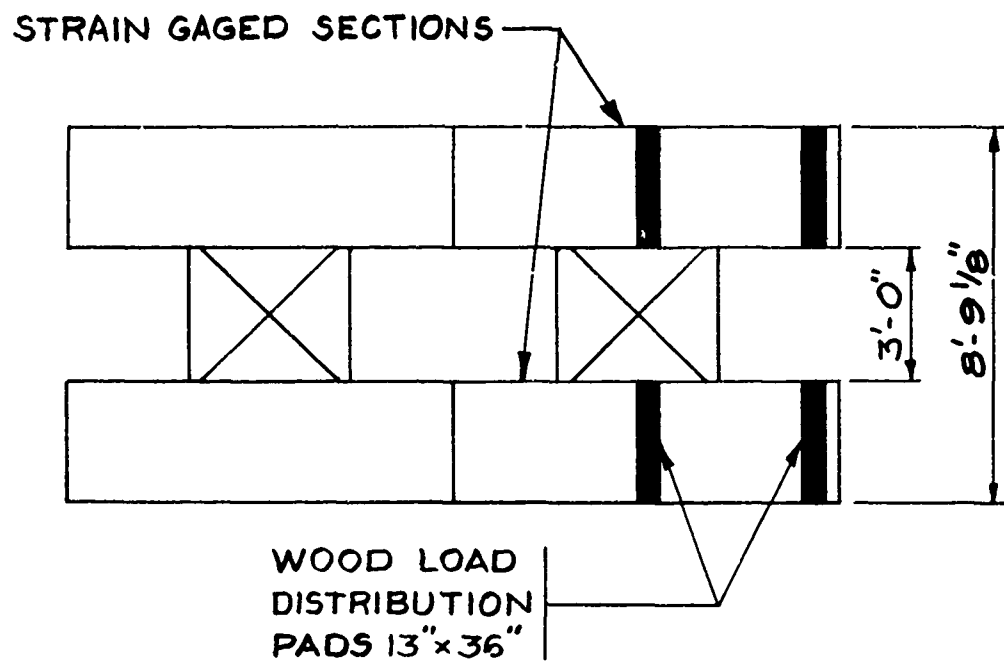
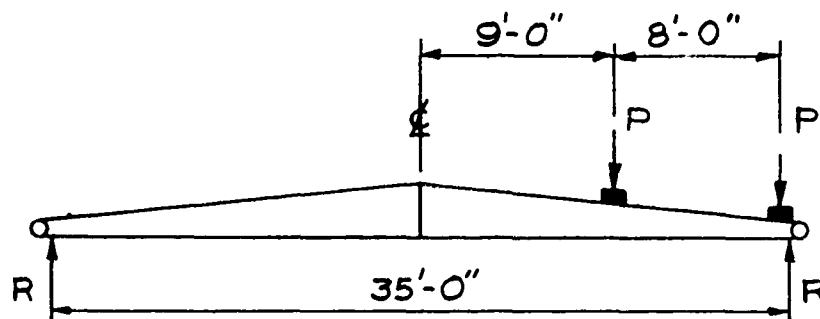
Fig. 11. Load Position 2.

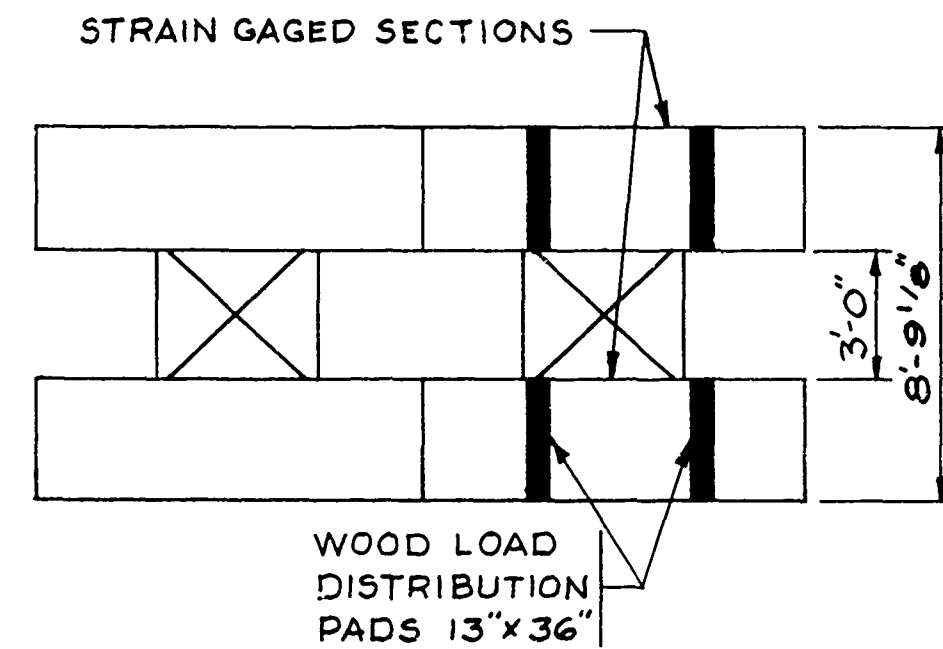
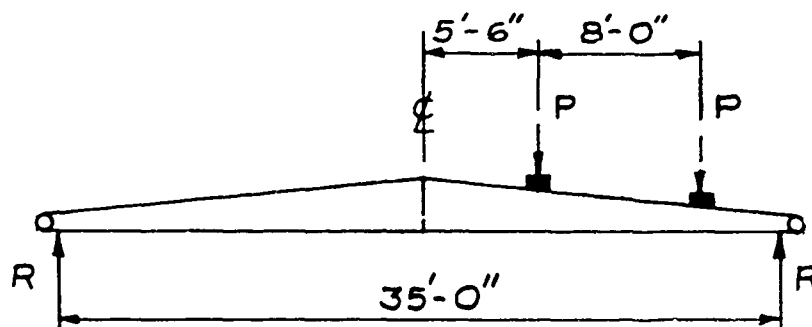
Fig. 12. Load Position 3.

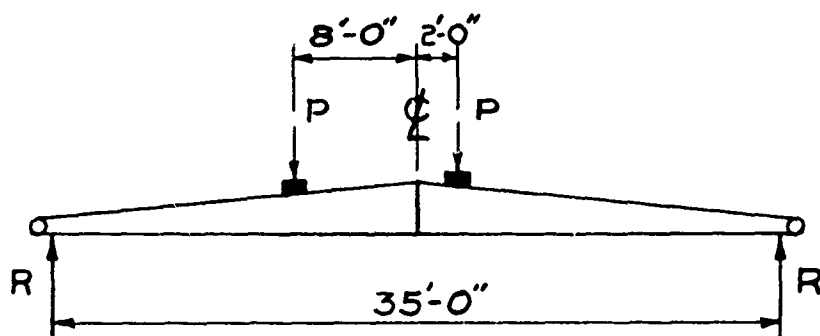
Fig. 13. Load Position 4A.

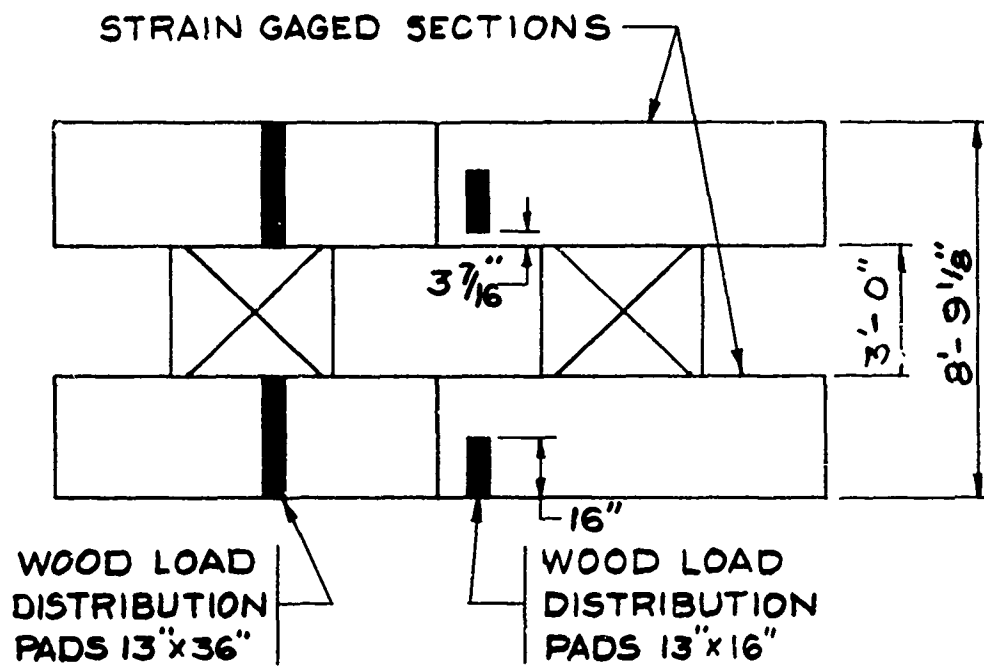
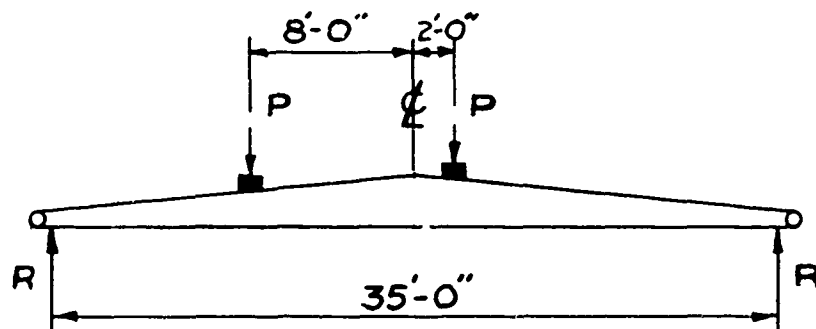
Fig. 14. Load Position 4B.

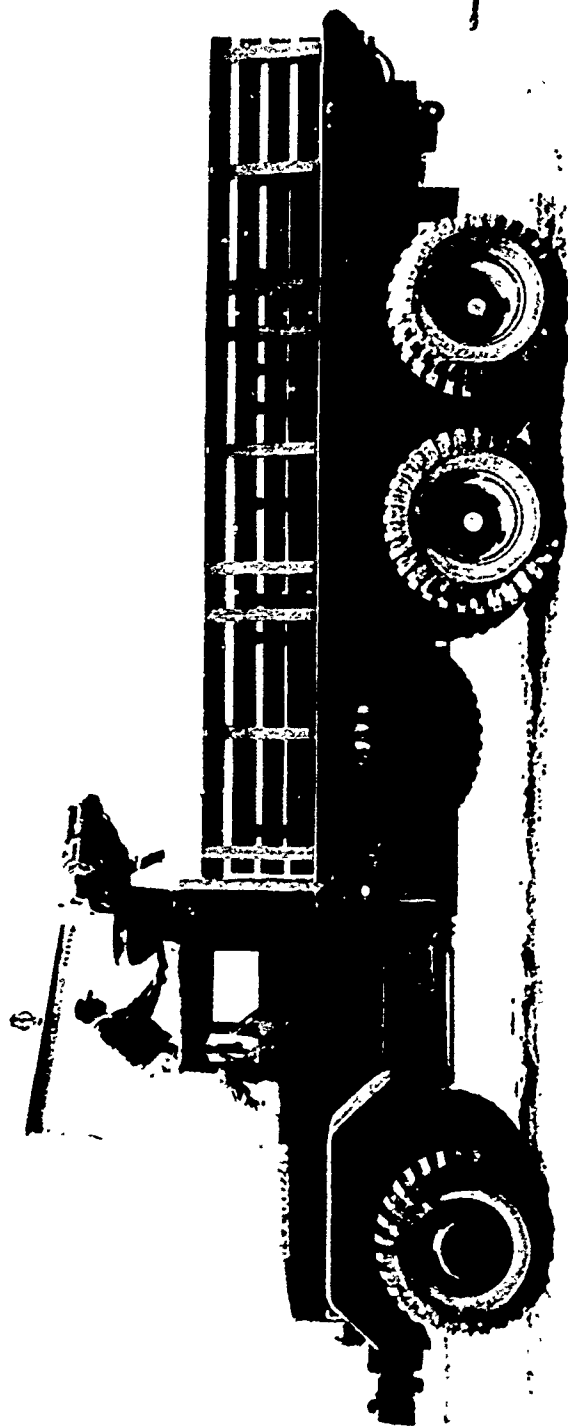
C3197

Fig. 16. Five-ton bridge truck, class 22.

The wheeled vehicle was an M-139 bridge truck loaded to a gross weight of 44,000 pounds (Fig. 16). Crossing speeds were limited to a crawl because only the inside, dual wheels of each rear axle were on the bridge. This created an extreme condition of weight (Class 22) and eccentricity, but the stresses show no areas of concern and the stress levels were well within the limits of proportionality (Table VII). Runs 1 and 2 show variations in different crossings, while run 3 shows the static stresses with the center of gravity (C.G.) of the vehicle at the centerline of the bridge.

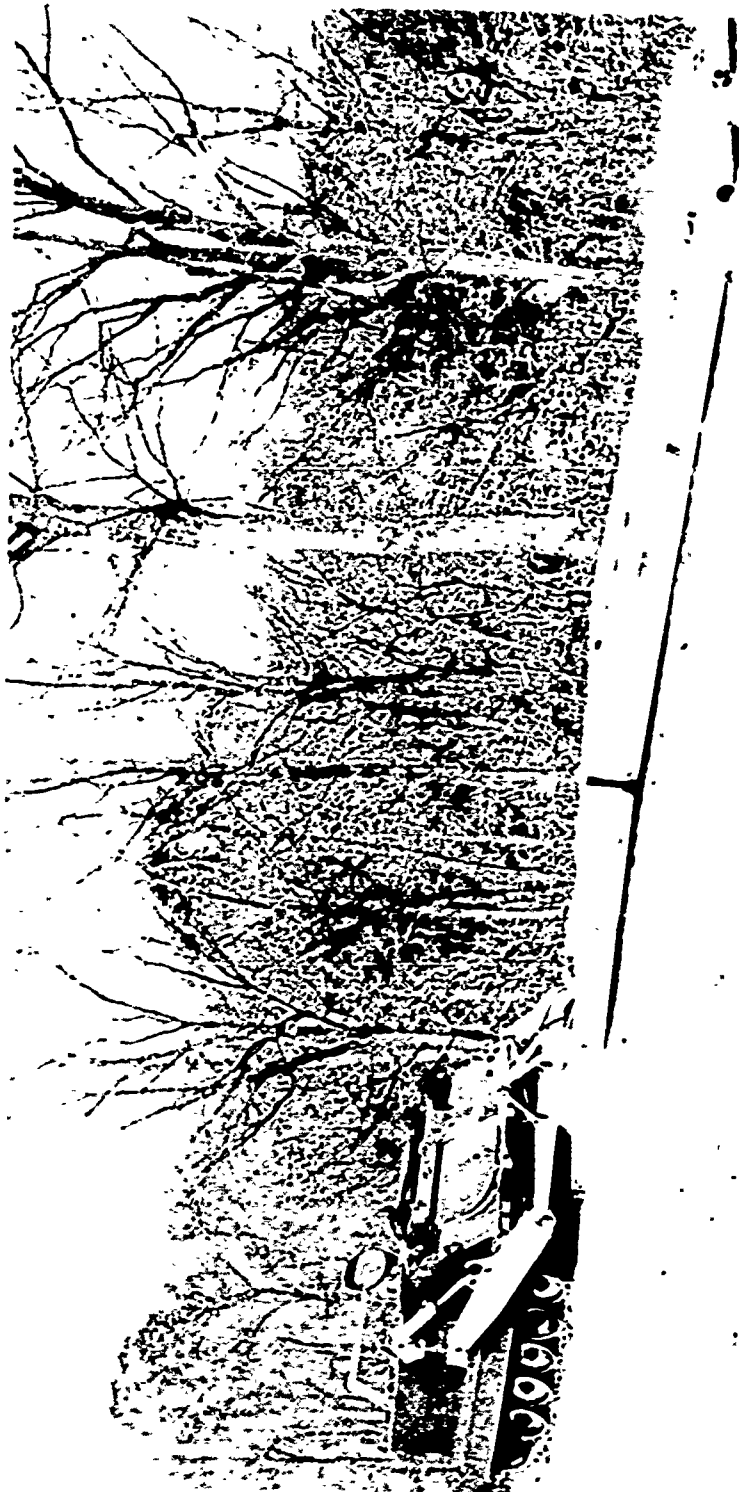
N10767

Fig. 17. Launcher attached to bridge.

The bridge was attached to the launcher and raised to the travel position (Figs. 17, 18, 19, and 20). The launcher with bridge attached was then driven into the water to establish its swimming capability (Fig. 21). Several trials were made with ballast placed at the rear of the vehicle; however, a better attitude was achieved with a combination surfboard-float placed at the front of the vehicle (Fig. 22).

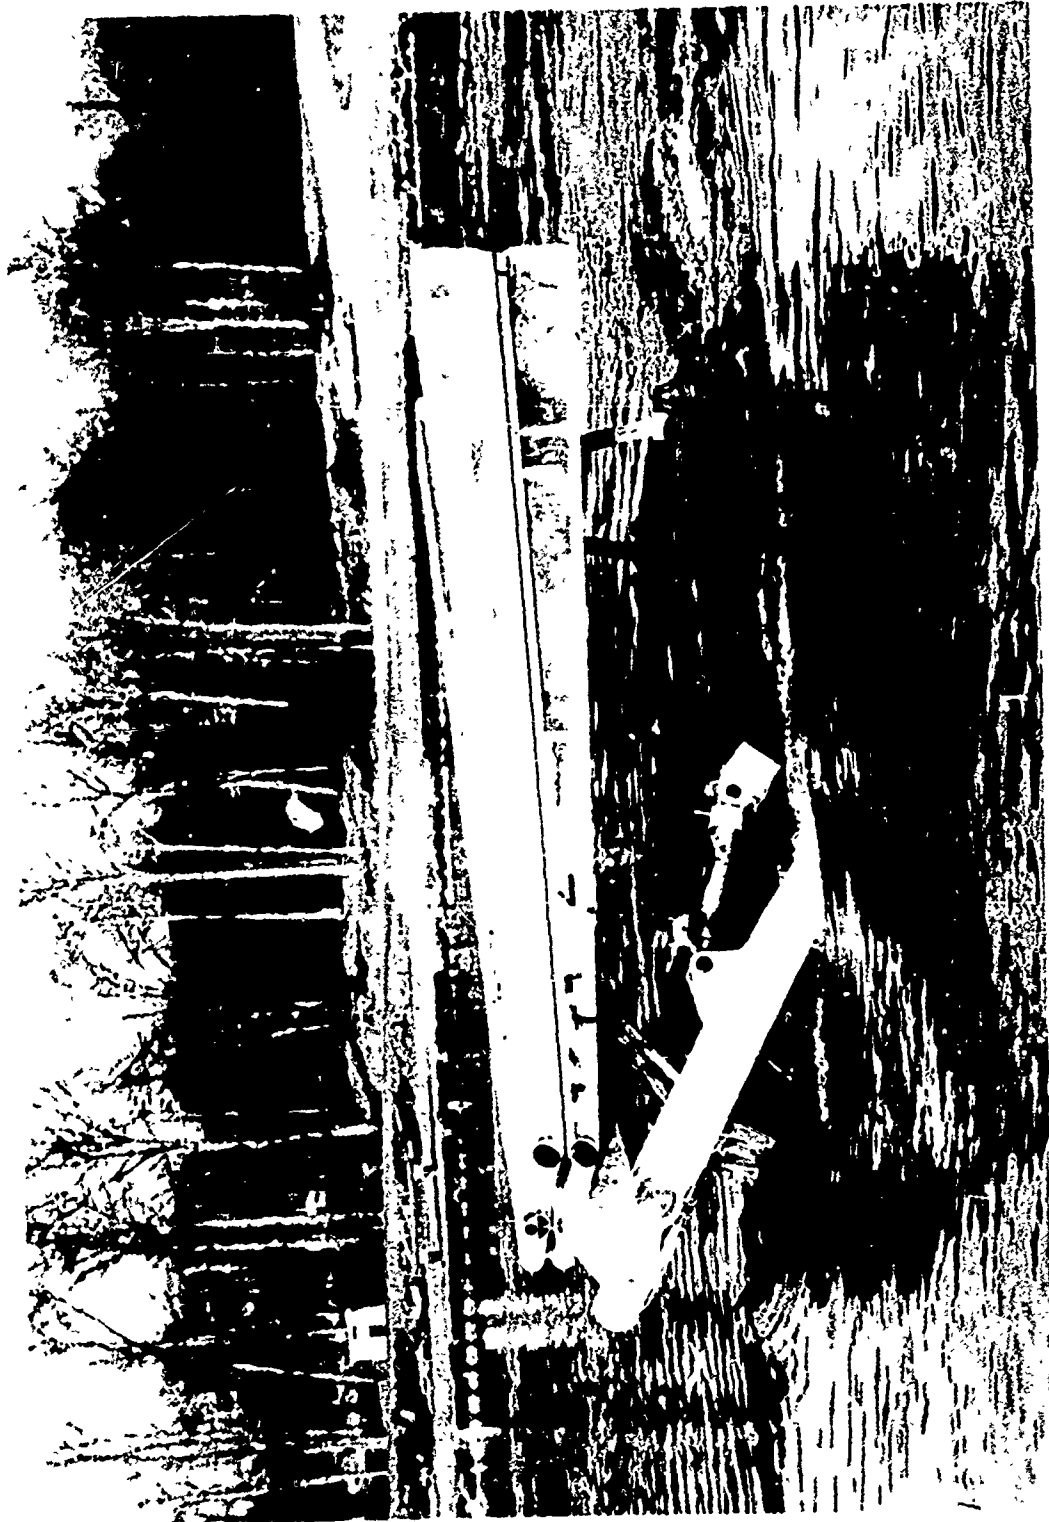
N1118

Fig. 22. Unit at full speed using combination surfboard-float.

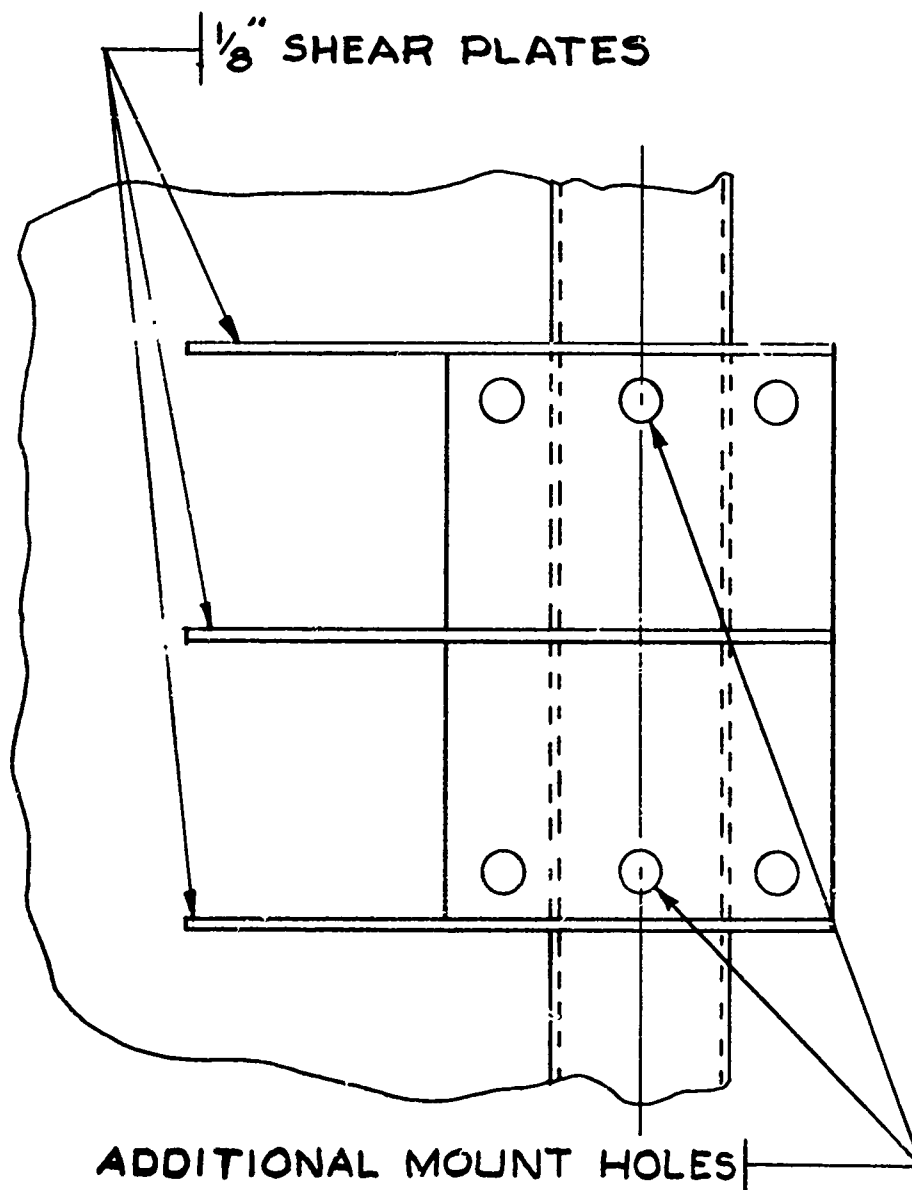
Fig. 25. Modified link beam mount.

During the initial stages of cycling, yielding occurred in the channel legs at the mounts for the cylinder beam and link beam. Elongation of the bolt holes was also noted. Shear plates 1/8-inch thick were added as well as four more bolts per beam. Fig. 25 shows the revised mount for the link beam. The cylinder beam mounts were similarly modified. Both areas were subjected to more than 1000 cycles without further evidence of distress.

Several weld failures occurred during the cycling including failure of the weld at the link beam and cross-bracing mounts. The welds were generally of poor quality, or incorrect in size and type, or both. The only modification was the addition of load distribution plates at the upper,

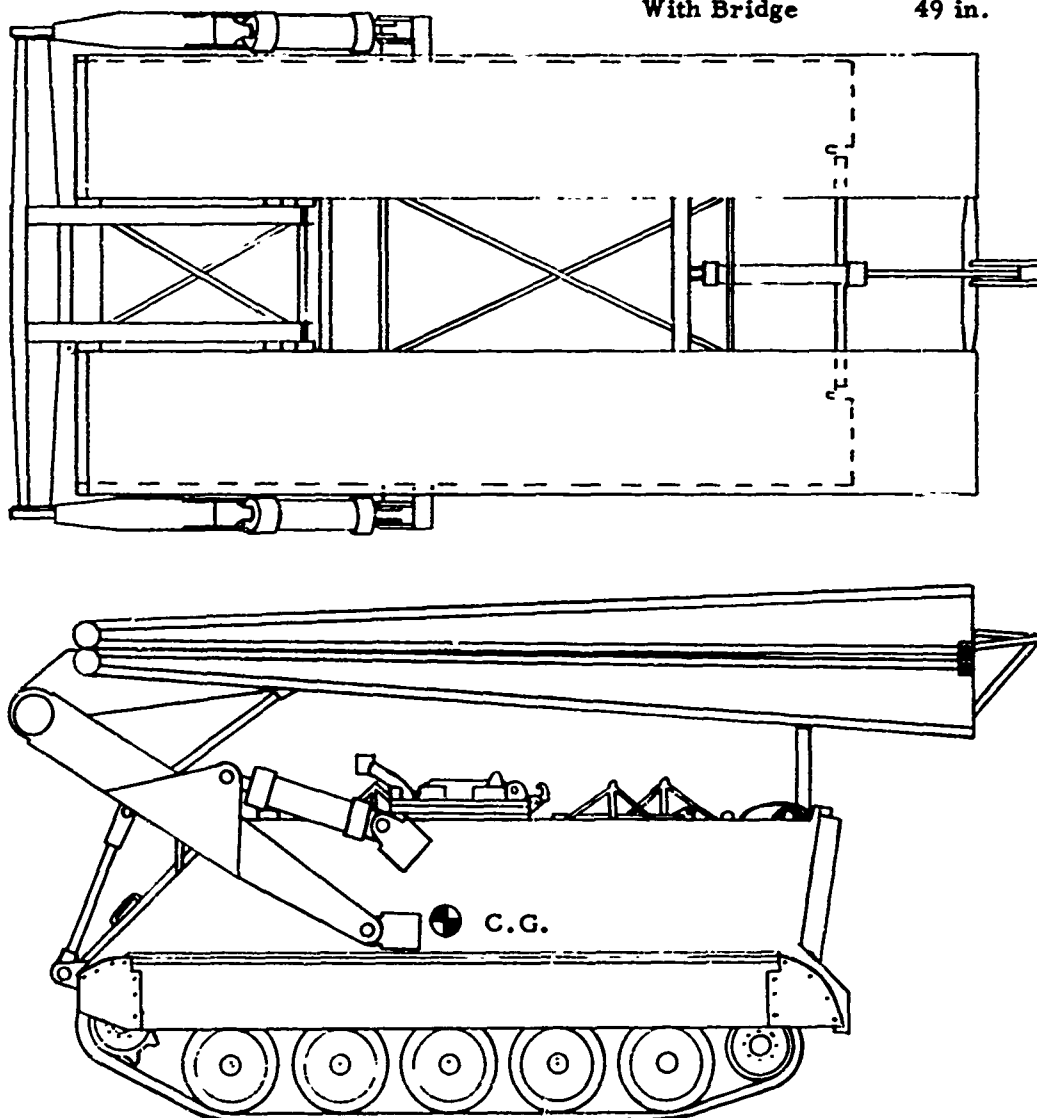
Crew	2	Height	
Weight		Without Bridge	109-1/4 in.
Without Bridge	20,250 lb.	With Bridge	136-1/2 in.
With Bridge	23,000 lb.	Center of Gravity	
Width	123-1/2 in.	(from noseline)	
Length		Horizontal	
Without Bridge	209-1/2 in.	Without Bridge	83-1/2 in.
With Bridge	249 in.	With Bridge	90 in.
		Vertical	
		Without Bridge	38 in.
		With Bridge	49 in.

Fig. 27. General data.

(1)	Initial weight of launcher	18,300 pounds
(2)	Final weight	
	(a) Without bridge	20,250 pounds
	(b) With bridge	23,000 pounds
(3)	Height	
	(a) Without bridge	109-1/4 inches
	(b) With bridge	136-1/2 inches
(4)	Width	123-1/2 inches
(5)	Length	
	(a) Without bridge	209-1/2 inches

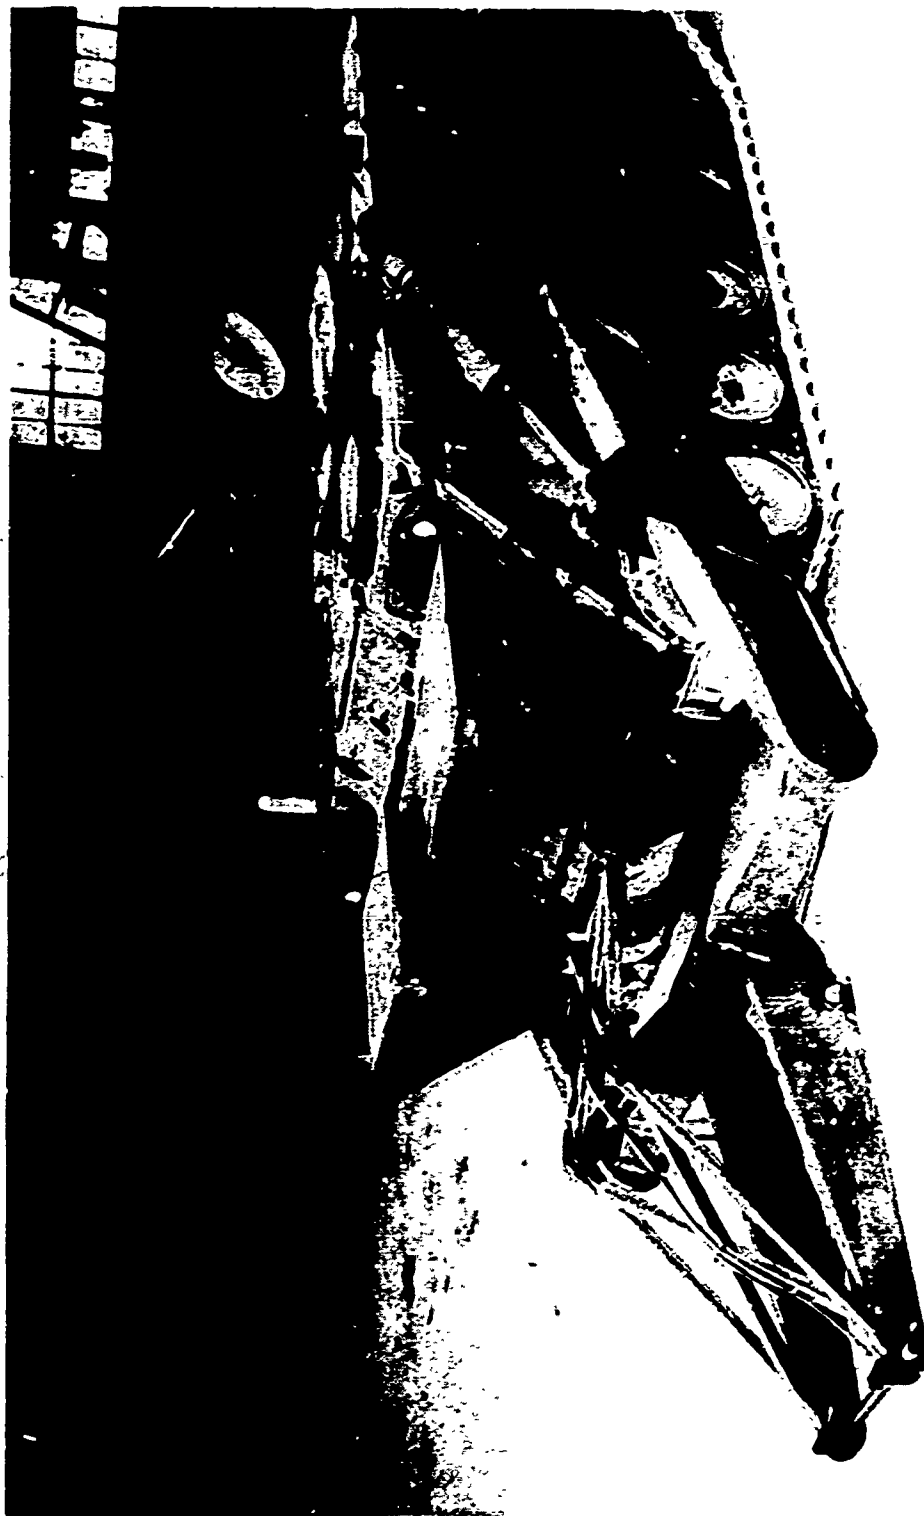
P7901

Fig. 28. Final surfboard-float arrangement.
